Repeating Defects

Xerox® Altalink® B8245/B8255/B8270
Multifunction Printer

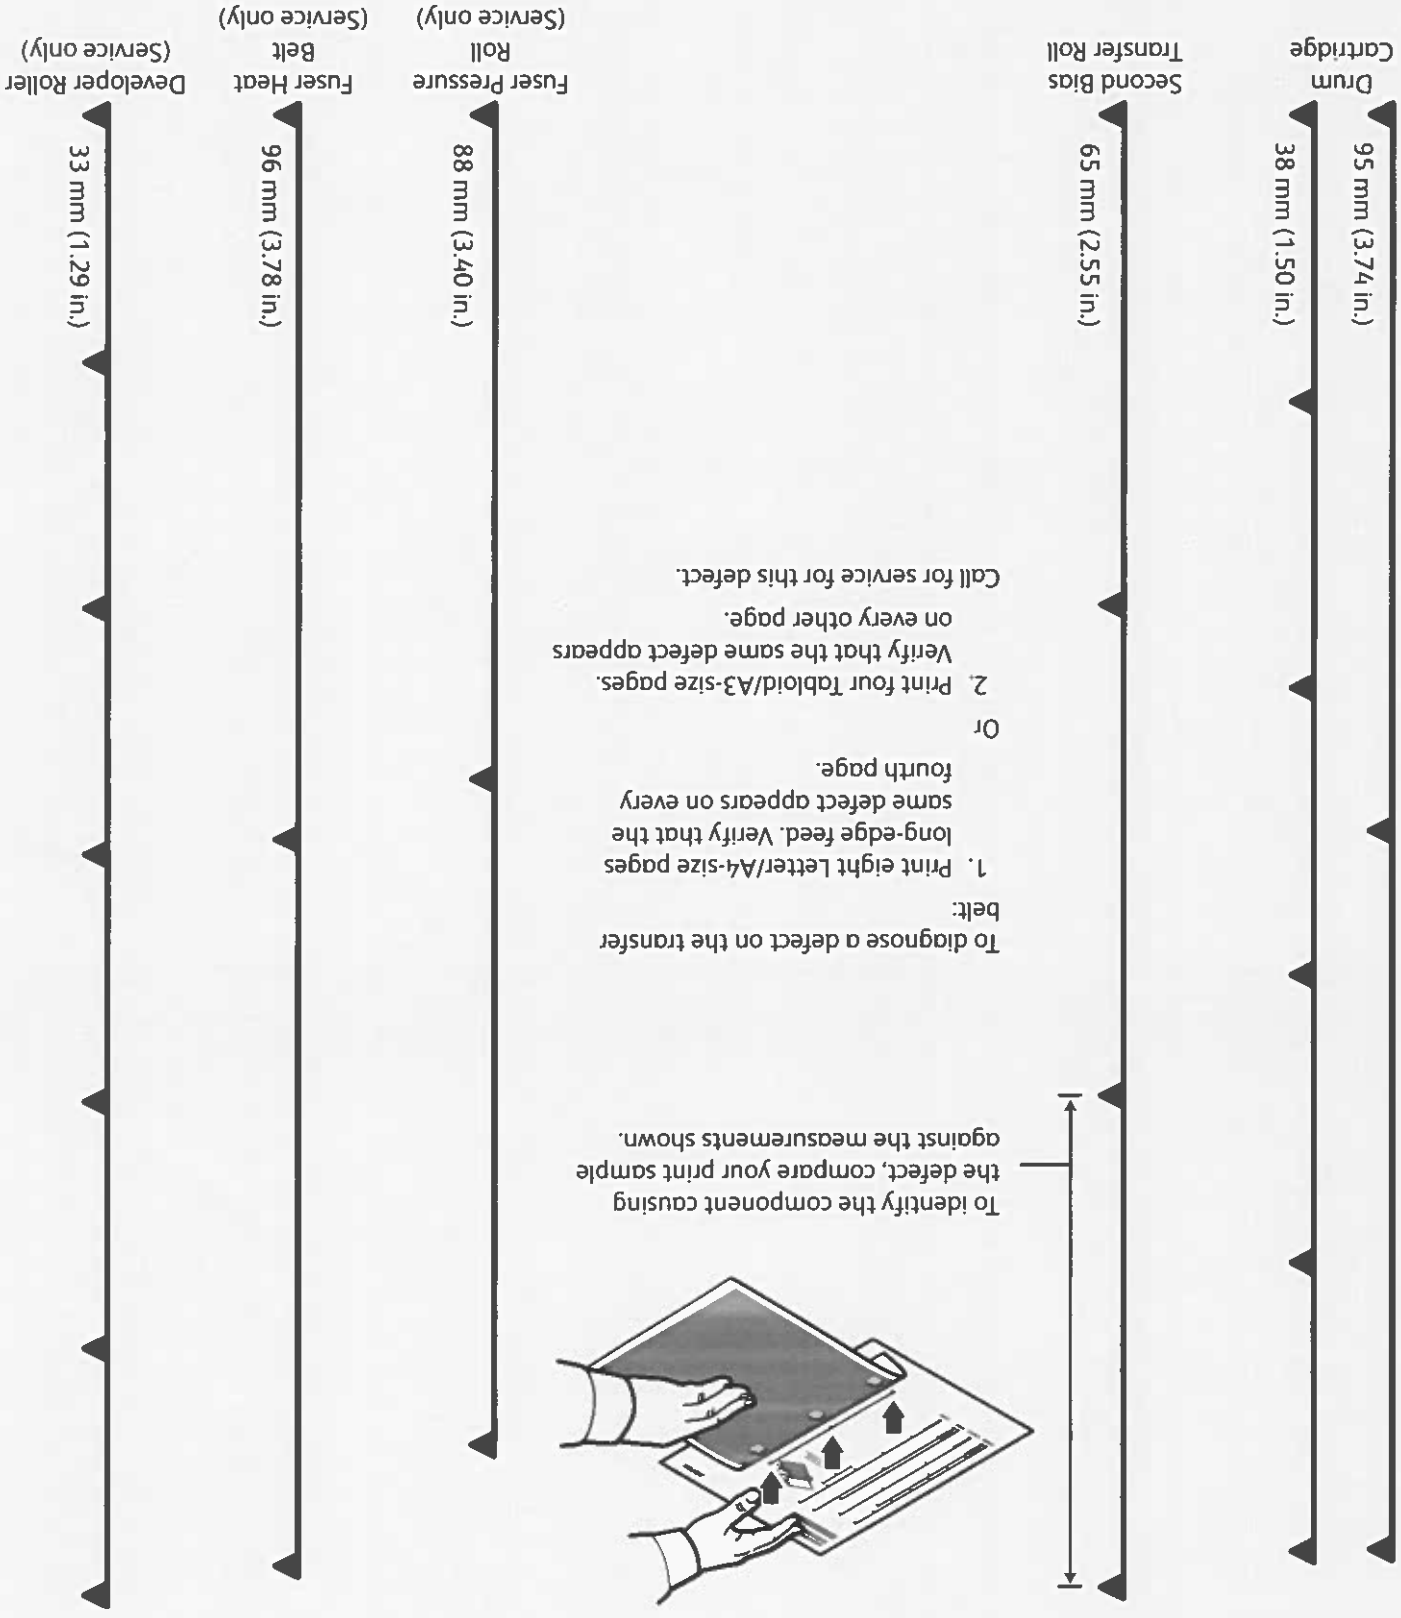
To identify the component causing the defect, compare your print sample against the measurements shown.

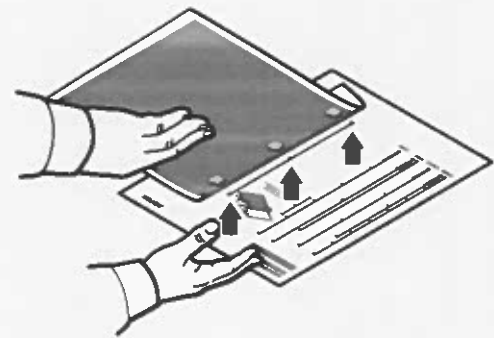
To diagnose a defect on the transfer belt:

1. Print eight Letter/A4-size pages long-edge feed. Verify that the same defect appears on every fourth page.
- Or
2. Print four Tabloid/A3-size pages. Verify that the same defect appears on every other page.

Call for service for this defect.
